**Re: Dangerous Waste Compliance Inspection on January 21, 2015 at McFarland Cascade,
aka Stella-Jones, RCRA Site ID: WAD053823019**

RCRA Site ID: WAD053823019	Facility Name: McFarland Cascade/Stella-Jones	Inspection Date: January 20, 2015
Generator Status: LQG	Facility Address: 6520 188th St NE, Arlington WA 98223	Date Report Sent: March 11, 2015

Inspection Report

PHOTO LOG

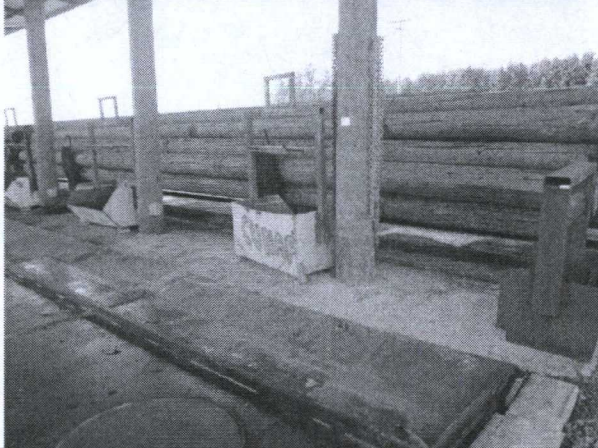
Walk-through of the retort area included visual inspection of the new steel drip pad surfaces for retorts 2 and 3 (Photos 1 & 2). Plans for upgrades were not submitted to this department prior to work being done. This is noted as a violation above (WAC 173-303-675(2)(b)). No treated logs were on the eastern most drip pad (retort 2), but a charge was on the retort 3 drip pad at the time of our inspection. Mr. Hillery stated that the drip pads had been refurbished in 2014. Mr. Hillery mentioned that the old pads were the same shape as the new ones, but concrete. Tracks were pulled up and replaced. The inspection ports located at the north end of each pad were sealed with steel during the renovation. All drips from treated poles run into collection pans located at the north end of each retort (Photo 6). Mr. Hillery said that debris on the pads is swept up and collected in a satellite drum located near retort 2. We observed this drum at the north end of the building's catwalk. This drum is under the roof of the building with secondary containment provided by the cement containment which surrounds all tanks within the building. The 55-gallon metal drum was properly

A black and white close-up photograph of a drip pad. A finished charge of poles is sitting on the drip pad. The poles are stacked and appear to be made of wood or a similar material. The drip pad is made of metal and is situated under a large, open-sided structure.
<p>#3 Retort Area</p> <p>North end of retort. Picture shows satellite 55-gallon drum containing F001, D001 waste solids and empty blue pail adjacent to drum.</p>

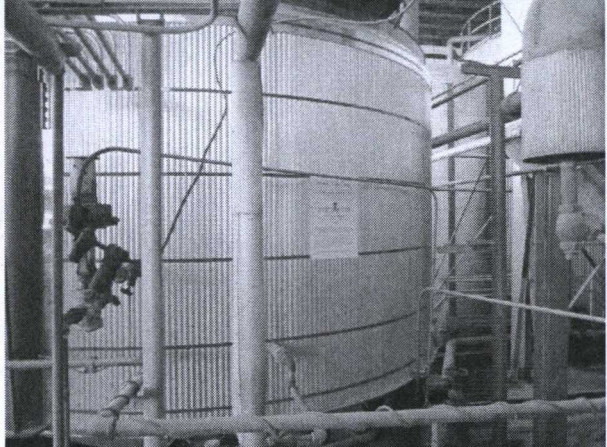
Area & Description	Photographs
<p>#9 Retort Area</p> <p>Oil-water separators for process water recycling and re-use.</p>

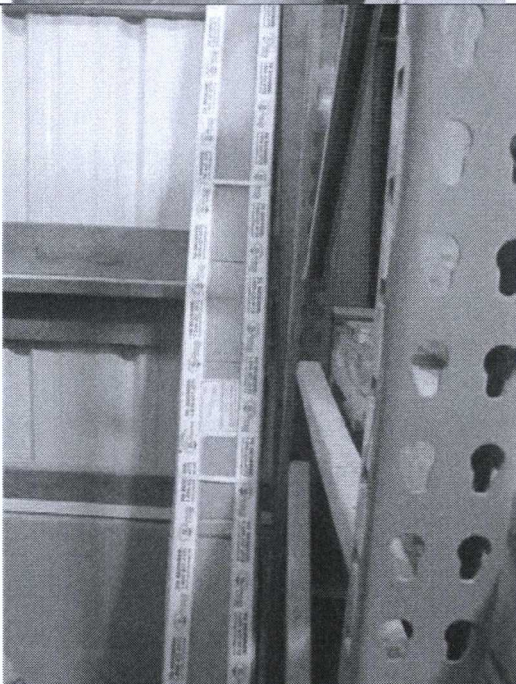
During the inspection I noted batteries and fluorescent lamps over their threshold time limits and asked Mr. Hillery to ship them off as quickly as possible. On February 16, Mr. Hillery emailed a scanned copy of a manifest showing the Universal Waste had been shipped offsite on February 4, 2015.

Area & Description	Photographs
<p>#16 Waste Accumulation Area</p> <p>A start date of 12/4/2013 was written on this box of Universal Waste lamps indicating the box is over the one year time limit (also shown in photo 15).</p>

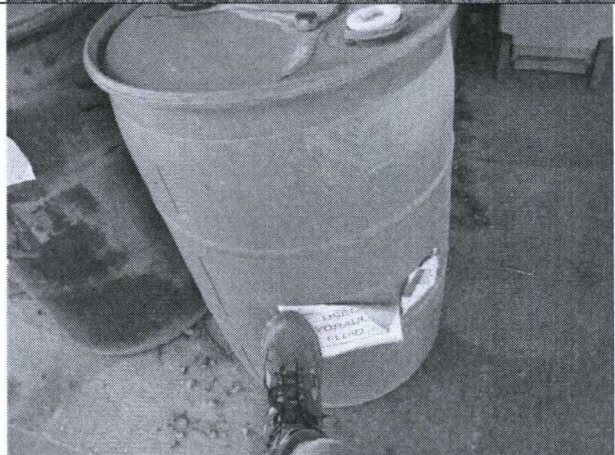
A black and white photograph showing four large drums lined up against a wooden wall. From left to right: a dark drum with a label, a light-colored drum, a dark drum with a label, and a light-colored drum. A small oil pan sits on top of the first dark drum.
<p>#19 Oil Area</p> <p>The label needed to be turned a bit to see the label identifying the contents as used hydraulic fluid. The drum lacked a used oil label.</p>

<p>#20 Oil Area</p> <p>It is suggested that a newer label be affixed to the drum and if possible move inside to help prevent peeling, illegible labels.</p>

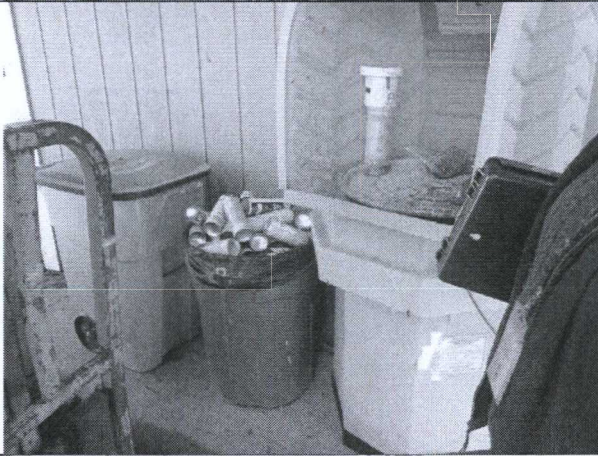
<p>#23 Oil Area</p> <p>Open, unlabeled container of used oil found on top of one drained oil filter drum.</p>
